I-35/80 & US6 (Hickman Road) Interchange Reconstruction

ACEC

September 26, 2025

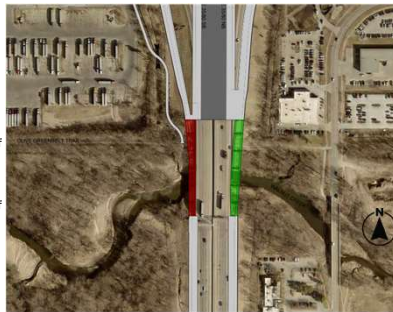
I-35/I-80 at Walnut Creek

I-35 SB / I-80 WB (red)

- Negligible grade changes across existing roadway, up to 17 feet of fill along the existing side slopes

I-35 NB / I-80 EB (green)

- Negligible grade changes across existing roadway, up to 14 feet of fill along the existing side slopes

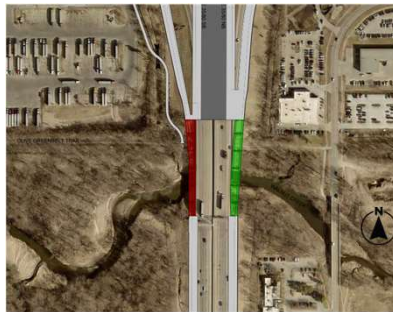
I-35/I-80 at Walnut Creek

I-35 SB / I-80 WB (red)

- Drag loads on bridge piles
- Settlement of approach pavements
- Global slope instability and inadequate bearing resistance below retaining Wall C

I-35 NB / I-80 EB (green)

- Drag loads on bridge piles
- Settlement of approach pavements
- Global slope instability and inadequate bearing resistance below retaining Wall B

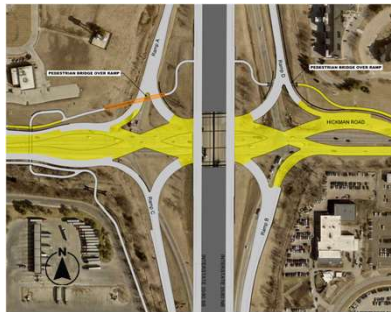
Pedestrian Trail Over Exit Ramp A

West Abutment

- Up to 10 feet of fill

East Abutment

- Up to 15 feet of fill

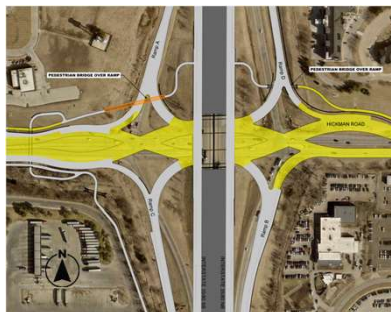
Pedestrian Trail Over Exit Ramp A

West Abutment

- Drag loads on bridge piles
- Settlement of trail at bridge abutment

East Abutment

- Drag loads on bridge piles
- Settlement of trail at bridge abutment
- Inadequate bearing resistance below retaining Wall A1

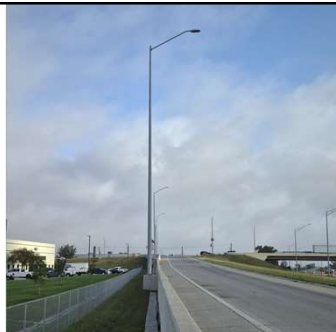
Proposed Lighting

- Continuous interstate lighting to be installed between University Avenue and Douglas Avenue
- Light poles to be installed along the interstate and ramps.
- No high mast tower lighting units will be utilized

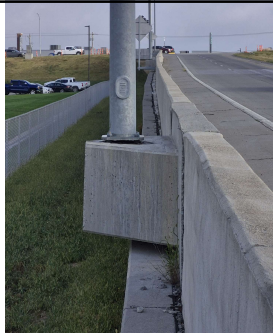
Design Considerations

- No light poles in the medians
 - Narrow median barrier section
 - Minimize interaction with sign trusses and storm sewers
 - Would require boring power feeds to the median under live traffic
- Light poles placed along roadway shoulder
 - Improves constructability and maintenance
 - Increased use of luminaires with wide light distribution (Type IV)
 - Required special retaining wall blister design
